# Asbestos Hazards and Controls – Joplin /Duquesne Tornado USACE Recovery Mission

**Matthew R. Scott**

CESAM-SO

15 March 2012

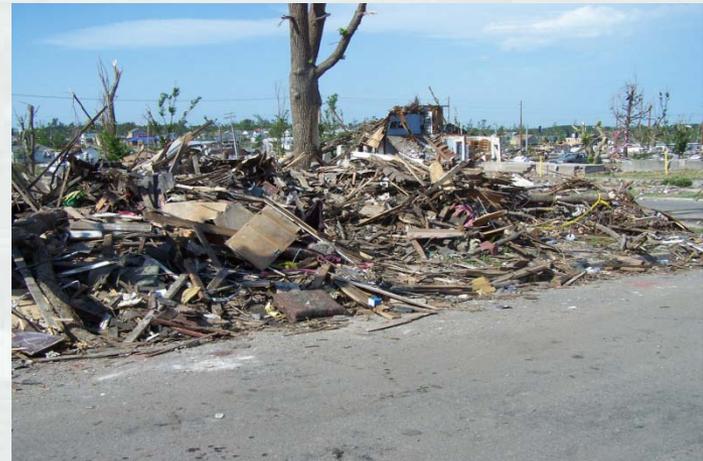
- May 22, 2011 – EF5 tornado struck the towns of Joplin and Duquesne, MO
- Damage: \$2.8 billion
- 161 fatalities
- Miles of debris
- Corps of Engineers assigned the debris removal mission by FEMA

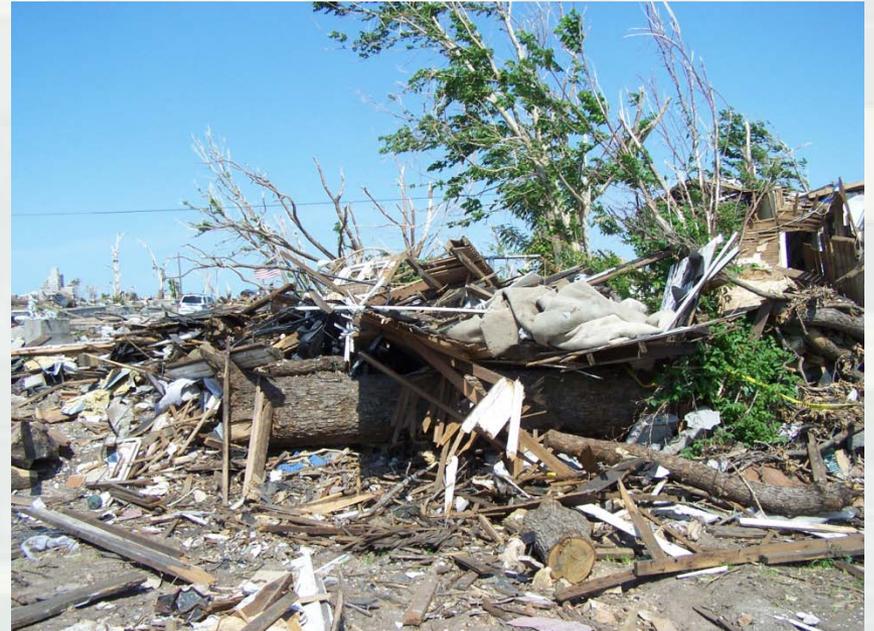
# Debris & ACM

- Primarily Residential
  - ▶ Transite Siding
  - ▶ TSI (1 case)
  - ▶ Other
- Intermingled with other debris

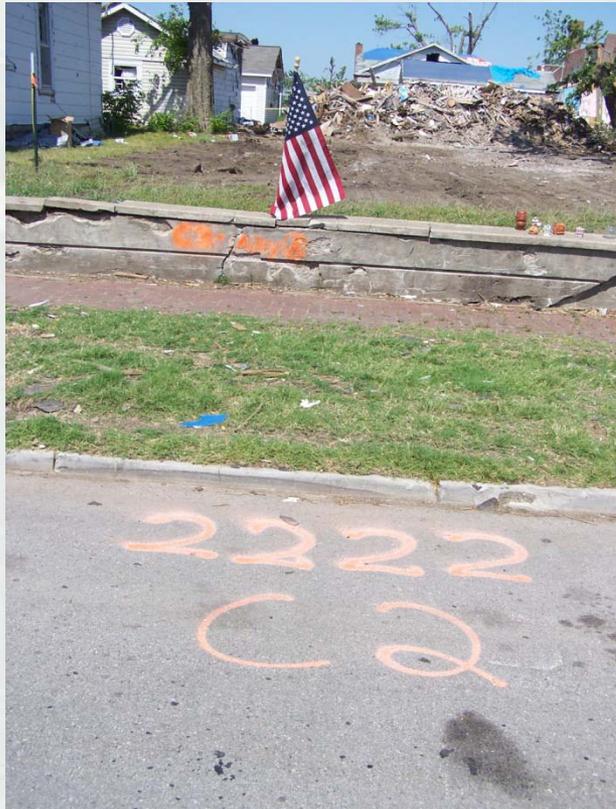
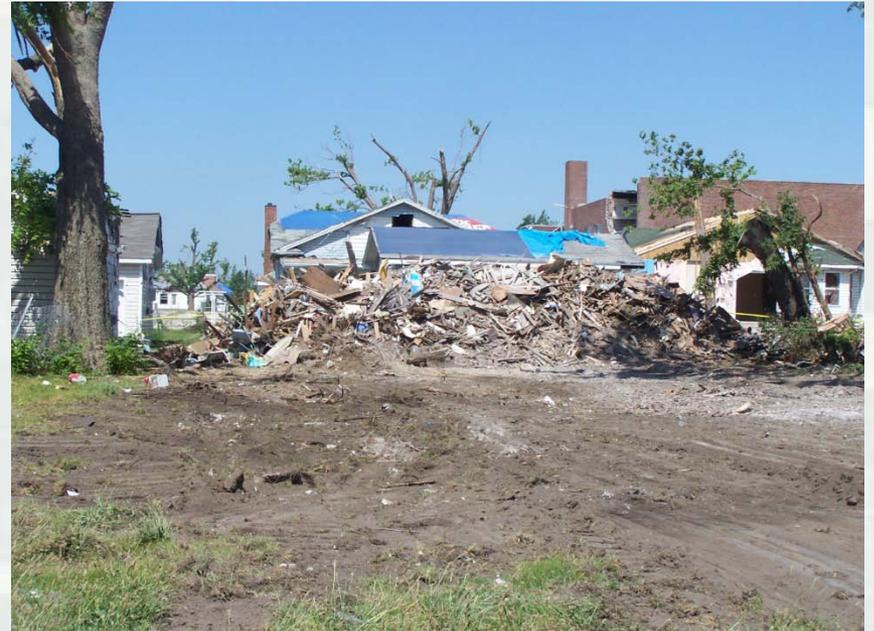
# Other Issues

- Degradation of markings
- Degradation of plastic during transport
- Non-USACE operations
  - ▶ Volunteers
  - ▶ Private Contractors
  - ▶ Homeowners
- General safety issues
- Pressure for progress
